Energy Audit and Retrofit Analysis at the EEB Hub

Energy Auditing Tool

Task 2.2 Energy Efficient Buildings Hub

Monday, 9 September 2013

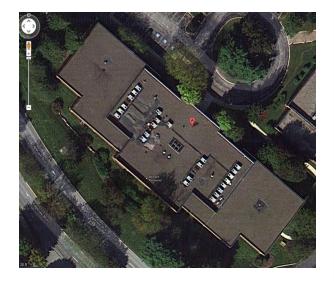
1 Sample Test Case - Overview

- Office building , built : 1990
- 32,000 ft2 of conditioned space, 1 floor
- Current occupancy: 128 employees plus 10 visitors on average
- Construction type: brick façade with strip windows
- Current EUI ~83.7 kBtuft2-yr

- 22 RTU electric heat pumps ranging from 5-10 tons
- All units run on individual thermostats
- No EMS system
- There are 3 server rooms with split system air conditioners for cooling

- The interior lighting is mostly T-12 recessed ceiling fixtures with manual controls
- Assumed light power density: 1.5 W/ft2

- There is assumed to be 1 computer and monitor per employee
- There is assumed to be 2 printers and 1 each photocopier, refrigerator and vending machine for the 8 office units
- Each office unit has a kitchenette which is supplied with hot water for the sink by a small electric tank heater that mimics a hot water on demand system
